**Flood Control Project Maintenance
Levee Inspections**

Fall 2016 Levee Maintenance Deficiency Summary Report

Reclamation District No. 2075 McMullin

Levee Inspection Report By Mile - Fall 2016

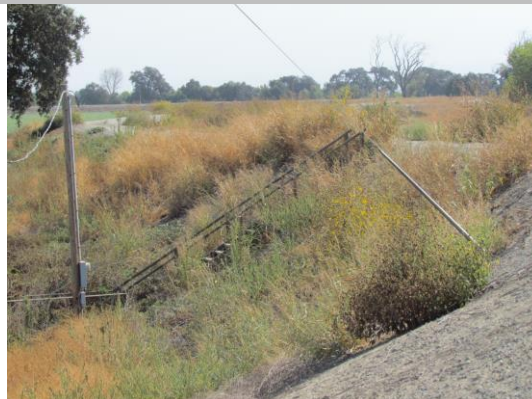
Photo 1 of 1 : FA_2016_RD2075_315_12_20160920_00025.jpg

LM Start	0.10	Rating **	U	Issue No.	12
LM End	0.53	Issue Type +	Ma	Location *	LS
Category	Earthen Levee			GPS Latitude/Longitude	
				Start	End
Item	Vegetation			37.748393 °	37.742588 °
				-121.289778 °	-121.288597 °
DWR ID	DWR_RD2075_01_f_2016_12				
Comment Code					
V1 : Control annual grass and weeds on the levee slopes and easements.					
Inspector Comment					
Weeds taller than three feet on the landside slope and shoulder need to be removed.

Looking downstream from levee mile 0.10 landside slope.

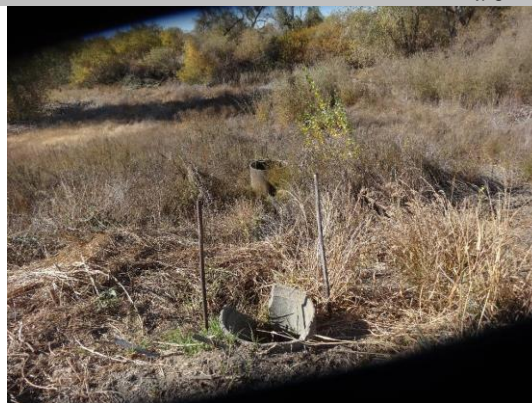
Photo 1 of 2 : UCIP_FA_2016_24663_44022.jpg

LM Start	0.12	Rating **	M	Issue No.	26
LM End	0.12	Issue Type +	En	Location *	LS
Category	Supplemental			GPS Latitude/Longitude	
				Start	End
Item	DWR UCIP Field Study			37.748200 °	37.748200 °
				-121.289717 °	-121.289717 °
DWR ID					
Comment Code					
Inspector Comment					
FS_ID:24663 DS_ID:24735 EP_NO: 4736 Repair Type: Non-Urgent Crossing Status: Found UCIP Comments: - pipe not visible on waterside.- no access to concrete riser on waterside.- blocked siphon breaker. FIELD_STRUCT_DESC: 14-inch steel pipe through the levee, 4.0 feet below the crown. Pump mounted on pile structure in drainage ditch on the landside. Siphon breaker in concrete riser unit on the waterward slope. Concrete distribution box at the toe of waterward slope. (App. No. 4736 - E. E. Brown). O&M Manual SJR 003, Dec. 1968. FS Date: 11/13/2013

WS view: concrete standpipe (top) and concrete pipe riser (bottom) on levee slope.

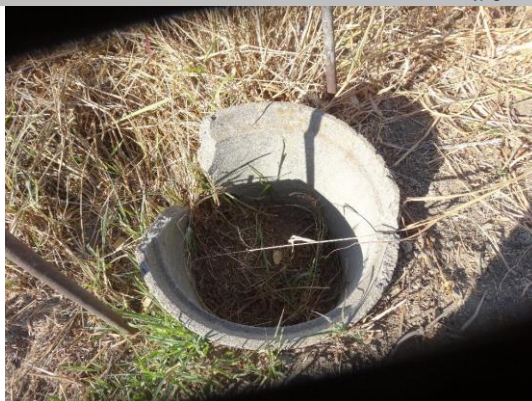
Photo 2 of 2 : UCIP_FA_2016_24663_44021.jpg

LM Start	0.12	Rating **	M	Issue No.	26 (cont)
LM End	0.12	Issue Type +	En	Location *	LS
Category	Supplemental			GPS Latitude/Longitude	
				Start	End
Item	DWR UCIP Field Study			37.748200 °	37.748200 °
				-121.289717 °	-121.289717 °
DWR ID					
Comment Code					
Inspector Comment					
FS_ID:24663 DS_ID:24735 EP_NO: 4736 Repair Type: Non-Urgent Crossing Status: Found UCIP Comments: - pipe not visible on waterside.- no access to concrete riser on waterside.- blocked siphon breaker. FIELD_STRUCT_DESC: 14-inch steel pipe through the levee, 4.0 feet below the crown. Pump mounted on pile structure in drainage ditch on the landside. Siphon breaker in concrete riser unit on the waterward slope. Concrete distribution box at the toe of waterward slope. (App. No. 4736 - E. E. Brown). O&M Manual SJR 003, Dec. 1968. FS Date: 11/13/2013

WS view: concrete pipe riser with siphon breaker on levee slope.

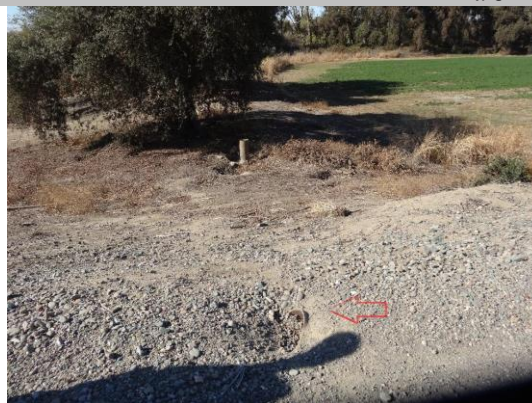
Photo 1 of 2 : UCIP_FA_2016_24666_45600.jpg

LM Start	2.32	Rating **	M	Issue No.	27
LM End	2.32	Issue Type +	En	Location *	LS
Category	Supplemental			GPS Latitude/Longitude	
				Start	End
Item	DWR UCIP Field Study			37.731314 °	37.731314 °
				-121.293713 °	-121.293713 °
DWR ID					
Comment Code					
Inspector Comment					
FS_ID:24666					
DS_ID:24737					
EP_NO: N/A					
Repair Type: Non-Urgent					
Crossing Status: Found					
UCIP Comments: - service pole on landside.- looks abandoned.					
Walkway in dilapidated condition.					
FIELD_STRUCT_DESC: 16-inch pipe through the levee, 4.5 feet below the crown. Pump mounted on pile structure in drain ditch on the landward side. Siphon breaker in CM riser unit on the waterward slope.					
O&M Manual SJR 003, Dec. 1968.					
FS Date: 11/13/2013

WS view: concrete standpipe (top) and steel pipe riser (bottom marked) on levee slope.

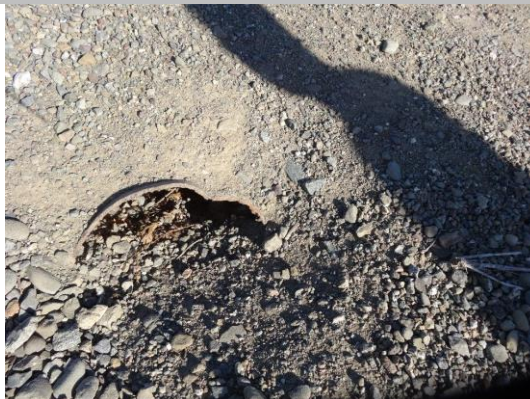
Photo 2 of 2 : UCIP_FA_2016_24666_44030.jpg

LM Start	2.32	Rating **	M	Issue No.	27 (cont)	
LM End	2.32	Issue Type +	En	Location *	LS	
Category	Supplemental			GPS Latitude/Longitude		
				Start	End	
Item	DWR UCIP Field Study			37.731314 °	37.731314 °	
				-121.293713 °	-121.293713 °	
DWR ID						
Comment Code						
Inspector Comment						
FS_ID:24666						
DS_ID:24737						
EP_NO: N/A						
Repair Type: Non-Urgent						
Crossing Status: Found						
UCIP Comments: - service pole on landside.- looks abandoned.						
Walkway in dilapidated condition.						
FIELD_STRUCT_DESC: 16-inch pipe through the levee, 4.5 feet below the crown. Pump mounted on pile structure in drain ditch on the landward side. Siphon breaker in CM riser unit on the waterward slope.						
O&M Manual SJR 003, Dec. 1968.						
FS Date: 11/13/2013

WS view: blocked siphon breaker in steel pipe riser on levee slope.

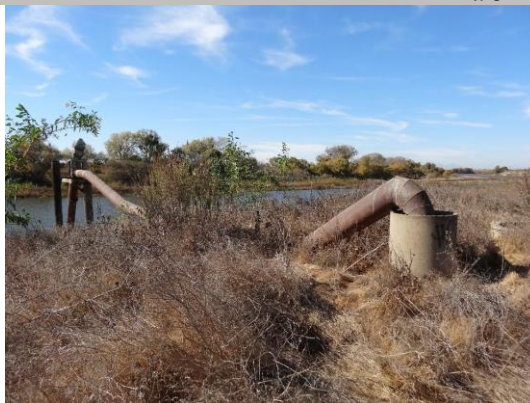
Photo 1 of 2 : UCIP_FA_2016_41721_45982.jpg

LM Start	3.86	Rating **	M	Issue No.	28
LM End	3.86	Issue Type +	En	Location *	LS
Category	Supplemental			GPS Latitude/Longitude	
				Start	End
Item	DWR UCIP Field Study			37.713744 °	37.713744 °
				-121.280712 °	-121.280712 °
DWR ID					
Comment Code					
Inspector Comment					
FS_ID:41721					
DS_ID:24746					
EP_NO: N/A					
Repair Type: Non-Urgent					
Crossing Status: Found					
UCIP Comments: Several concrete structure with Alfalfa valve. Only steel pipe visible on river bank. Service pole on waterside.New field discovered crossing.					
FIELD_STRUCT_DESC: 10-inch irrigation pvc pipe through the levee. Slant pump in river bank. Distribution box on levee berm on waterside. U type concrete headwall and open outlet on levee toe on landside.					
FS Date: 11/13/2013

WS view: slant pump and concrete distribution box on levee berm.

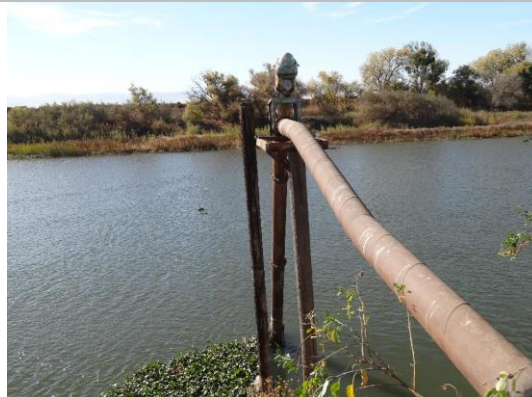
Photo 2 of 2 : UCIP_FA_2016_41721_45981.jpg

LM Start	3.86	Rating **	M	Issue No.	28 (cont)	
LM End	3.86	Issue Type +	En	Location *	LS	
Category	Supplemental			GPS Latitude/Longitude		
				Start	End	
Item	DWR UCIP Field Study			37.713744 °	37.713744 °	
				-121.280712 °	-121.280712 °	
DWR ID						
Comment Code						
Inspector Comment						
FS_ID:41721						
DS_ID:24746						
EP_NO: N/A						
Repair Type: Non-Urgent						
Crossing Status: Found						
UCIP Comments: Several concrete structure with Alfalfa valve. Only steel pipe visible on river bank. Service pole on waterside.New field discovered crossing.						
FIELD_STRUCT_DESC: 10-inch irrigation pvc pipe through the levee. Slant pump in river bank. Distribution box on levee berm on waterside. U type concrete headwall and open outlet on levee toe on landside.						
FS Date: 11/13/2013

WS view: slant pump on timber pile in the stream.

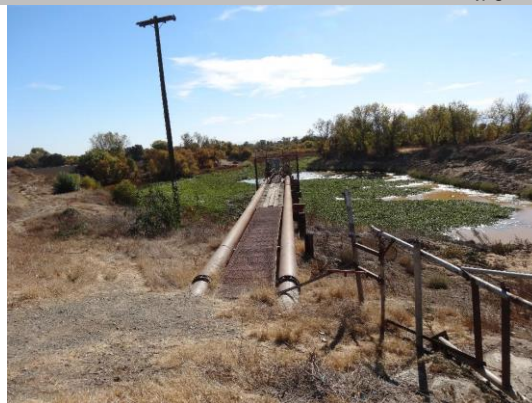
Photo 1 of 2 : UCIP_FA_2016_50209_45603.jpg

Comment Code					
Inspector Comment					
FS_ID:50209					
DS_ID:24739					
EP_NO: N/A					
Repair Type: Non-Urgent					
Crossing Status: Found					
UCIP Comments: - flap gates in concrete box on LS toe have failed and are open. Rusted through flapgate may indicate condition of interior of pipe.					
FIELD_STRUCT_DESC: 1 of 2: Two 16-inch steel irrigation pipes through the levee, 8 feet below the crown. Pump mounted on a pile structure in the river. Walkway to the pumps. Siphon breakers and concrete distribution box on the landside (LS) slope. Electric conduit through the levee. [Additional Reference(s): DWR Levee Log, 2005. USACE San Joaquin O&M Manual 003, Dec 1968 (HLM 5.16)].					
FS Date: 6/21/2016

WS view: two pipes, walkway to pump and pile structure in the stream.

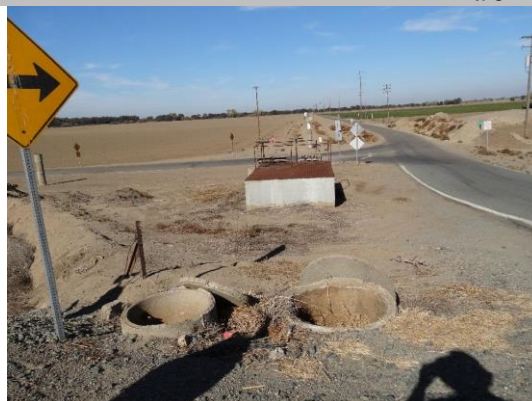
Photo 2 of 2 : UCIP_FA_2016_50209_45602.jpg

Comment Code						
Inspector Comment						
FS_ID:50209						
DS_ID:24739						
EP_NO: N/A						
Repair Type: Non-Urgent						
Crossing Status: Found						
UCIP Comments: - flap gates in concrete box on LS toe have failed and are open. Rusted through flapgate may indicate condition of interior of pipe.						
FIELD_STRUCT_DESC: 1 of 2: Two 16-inch steel irrigation pipes through the levee, 8 feet below the crown. Pump mounted on a pile structure in the river. Walkway to the pumps. Siphon breakers and concrete distribution box on the landside (LS) slope. Electric conduit through the levee. [Additional Reference(s): DWR Levee Log, 2005. USACE San Joaquin O&M Manual 003, Dec 1968 (HLM 5.16)].						
FS Date: 6/21/2016

LS view: siphon breakers in concrete pipe risers (bottom) on levee slope. Concrete distribution box on levee toe (top).

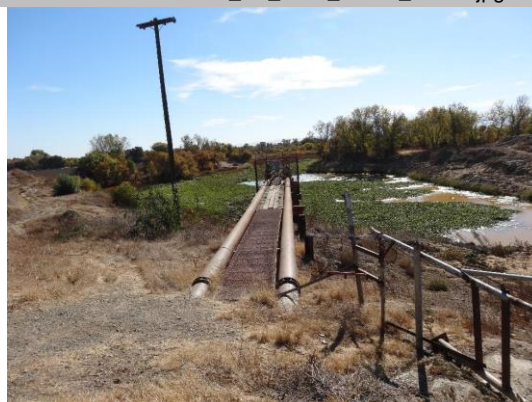
Photo 1 of 2 : UCIP_FA_2016_25184_45608.jpg

LM Start	5.20	Rating **	M	Issue No.	25
LM End	5.20	Issue Type +	En	Location *	LS
Category	Supplemental			GPS Latitude/Longitude	
				Start	End
Item	DWR UCIP Field Study			37.728848 °	37.728848 °
				-121.275195 °	-121.275195 °
DWR ID					
Comment Code					
Inspector Comment					
FS_ID:25184					
DS_ID:24743					
EP_NO: N/A					
Repair Type: Non-Urgent					
Crossing Status: Found					
UCIP Comments: Flap gate lid displaced.					
FIELD_STRUCT_DESC: 2 of 2: Two 16-inch pipes through the levee, 8.0 feet below the crown. Pump mounted on pile structure in the river. Walkway to the pumps. Siphon breakers and concrete distribution box on the landward slope. Electric conduit through the levee. O&M Manual SJR 003, Dec. 1968.					
FS Date: 11/13/2013

WS view: two pipes, walkway to pump and pile structure in the stream.

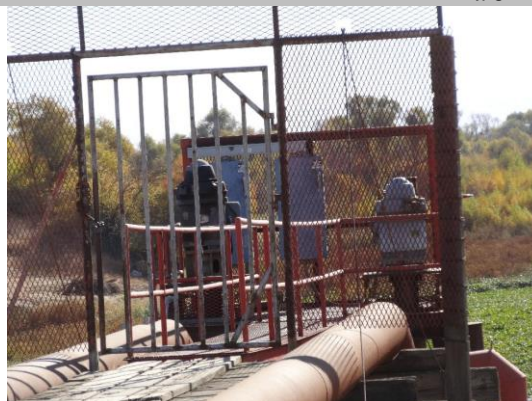
Photo 2 of 2 : UCIP_FA_2016_25184_45607.jpg

LM Start	5.20	Rating **	M	Issue No.	25 (cont)
LM End	5.20	Issue Type +	En	Location *	LS
Category	Supplemental			GPS Latitude/Longitude	
				Start	End
Item	DWR UCIP Field Study			37.728848 °	37.728848 °
				-121.275195 °	-121.275195 °
DWR ID					
Comment Code					
Inspector Comment					
FS_ID:25184					
DS_ID:24743					
EP_NO: N/A					
Repair Type: Non-Urgent					
Crossing Status: Found					
UCIP Comments: Flap gate lid displaced.					
FIELD_STRUCT_DESC: 2 of 2: Two 16-inch pipes through the levee,					
8.0 feet below the crown. Pump mounted on pile structure in the river.					
Walkway to the pumps. Siphon breakers and concrete distribution box					
on the landward slope. Electric conduit through the levee. O&M Manual					
SJR 003, Dec. 1968.					
FS Date: 11/13/2013

WS view: closer view of two pumps and platform in the stream.

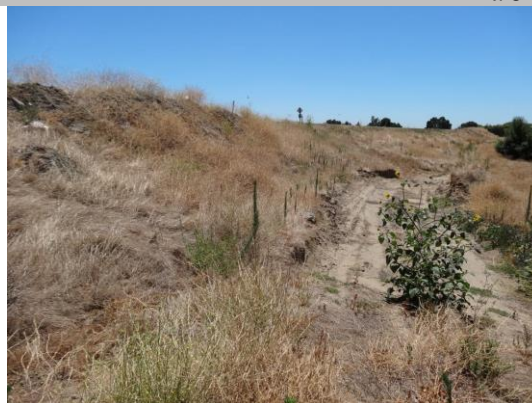
Photo 1 of 3 : SJR2016_RD2075U01RM64.34_1.jpg

Comment Code					
Inspector Comment					
07/12/2016: No significant change observed.					
08/28/2015: No significant change observed. Loose material is visible at the upper levee slope. The loose soil may have been caused by runoff.					
08/18/2014: No significant change observed.					
09/10/2013: No significant change observed.					
09/13/2012: No significant change observed.					
08/18/2011: No significant change observed. Some new material added to the water side levee slope, but the added material is loose and seems not helping the levee protection.					
10/05/2010: No significant change observed. Levee slope has minimal vegetation and lacks rip rap protection. Sandy material found on the lower and middle slope is an undesirable material to have on a levee.					
08/05/2010: Recommended for annual assessment and monitoring during flood events, per CLRO.					
08/20/2009: No major change since last visit; site is located in an oxbow; slope surface consists of very sandy material; there is a tree on site leaning and with exposed tree roots; site is recommended as a local maintenance issue, per CLRO CES Evaluation 2008 Report; Eddy Cordoza from the district is aware of the site and is looking for recommendation; site is previously rated "U".

08/17/2007: Site is close to an irrigation pump inlet. [2016 Site ID:RD2075U01RM64.34]

Upstream view of the erosion site.

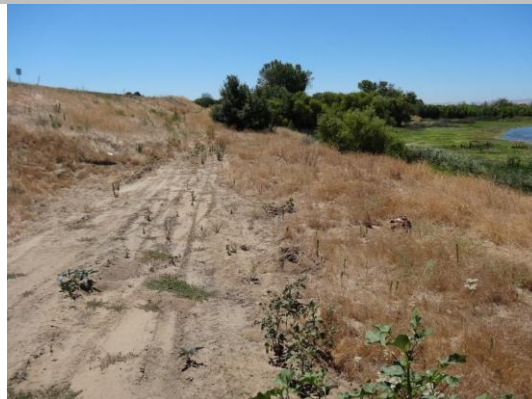
Photo 2 of 3 : SJR2016_RD2075U01RM64.34_3.jpg

Comment Code						
Inspector Comment						
07/12/2016: No significant change observed.						
08/28/2015: No significant change observed. Loose material is visible at the upper levee slope. The loose soil may have been caused by runoff.						
08/18/2014: No significant change observed.						
09/10/2013: No significant change observed.						
09/13/2012: No significant change observed.						
08/18/2011: No significant change observed. Some new material added to the water side levee slope, but the added material is loose and seems not helping the levee protection.						
10/05/2010: No significant change observed. Levee slope has minimal vegetation and lacks rip rap protection. Sandy material found on the lower and middle slope is an undesirable material to have on a levee.						
08/05/2010: Recommended for annual assessment and monitoring during flood events, per CLRO.						
08/20/2009: No major change since last visit; site is located in an oxbow; slope surface consists of very sandy material; there is a tree on site leaning and with exposed tree roots; site is recommended as a local maintenance issue, per CLRO CES Evaluation 2008 Report; Eddy Cordoza from the district is aware of the site and is looking for recommendation; site is previously rated "U".

Looking upstream at the site.

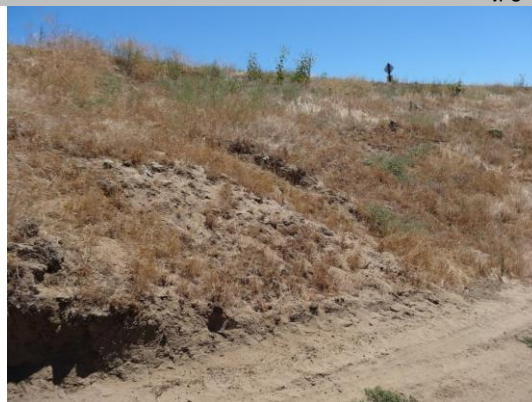
Photo 3 of 3 : SJR2016_RD2075U01RM64.34_4.jpg

Direct view of the levee slope. Note the loose soil possibly caused by runoff.

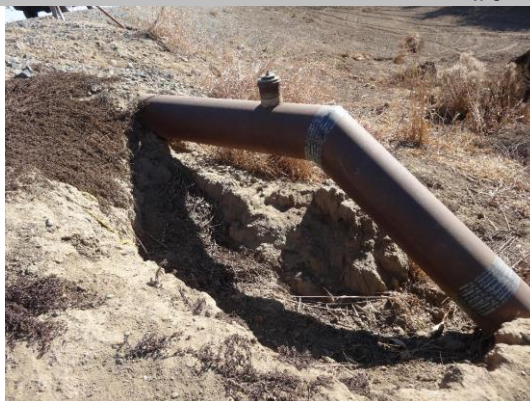
Photo 1 of 2 : UCIP_FA_2016_50191_44262.jpg

FS_ID:50191
DS_ID:24740
EP_NO: 3492
Repair Type: Non-Urgent
Crossing Status: Found
UCIP Comments: 06/21/2016 Rock revetment placed along WS slope beneath and around pipe; this corrected the levee erosion but still unclear whether the cause of the erosion was addressed. I found no evidence of siphon breaker leakage cited previously. Eddy Cardoza of RD2075 mentioned he saw no leak in and around pipe when the levee slope was repaired. Crossing was been downgraded from Urgent to Non-Urgent. (K. Fazel - UCIP)11/13/2013 Huge erosion on waterside levee slope due to siphon breaker leakage. It is not 16-inch but 12-inch steel pipe. Pump not mounted on pile structure but mounted on concrete sump. Siphon breaker not in concrete riser but on steel pipe. Pipe is not 8 ft. below the crown but 4 ft below the crown. Looks original pipe was replaced with new crossing. Needs more information from LMA or DWR Inspector. (P. Amatya - DWR)

FIELD_STRUCT_DESC: 12-inch (not 14-inch as referenced in Permit No. 3492-A) asphalt coated steel pipe through the levee, 4 feet below the crown. Pump mounted on a concrete sump in a drain ditch approximately 200 feet off the landside (LS) toe. Siphon breaker on the apex of the pipe through the waterside (WS) slope. (Permit No. 3492, 1962 - RD2075) (Additional Related Permit(s): 3492-A, 1969 - RD2075). [Additional Reference(s): DWR Levee Log, 2005. USACE San Joaquin O&M Manual 003, Dec 1968 (HLM 5.52)]. Note O&M Manual references a 16-inch pipe with a depth of 8 feet at this location, which was replaced under Permit No. 3492 with a 6-inch pipe, which was replaced with a 14-inch pipe under Permit No. 3492-A.
FS Date: 6/21/2016

WS view: siphon breaker on steel pipe on levee slope. Huge soil erosion due to siphon breaker leakage.

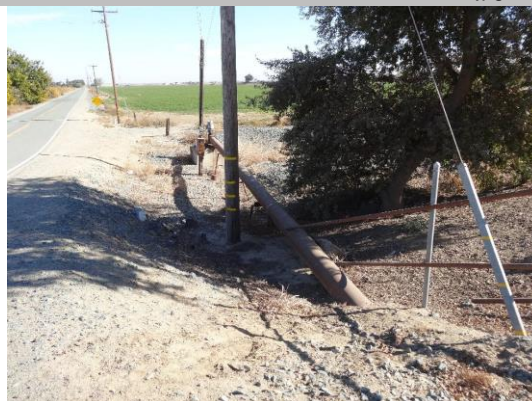
Photo 2 of 2 : UCIP_FA_2016_50191_44261.jpg

Comment Code						
Inspector Comment						
FS_ID:50191 DS_ID:24740 EP_NO: 3492 Repair Type: Non-Urgent Crossing Status: Found UCIP Comments: 06/21/2016 Rock revetment placed along WS slope beneath and around pipe; this corrected the levee erosion but still unclear whether the cause of the erosion was addressed. I found no evidence of siphon breaker leakage cited previously. Eddy Cardoza of RD2075 mentioned he saw no leak in and around pipe when the levee slope was repaired. Crossing was been downgraded from Urgent to Non-Urgent. (K. Fazel - UCIP)11/13/2013 Huge erosion on waterside levee slope due to siphon breaker leakage.It is not 16-inch but 12-inch steel pipe.Pump not mounted on pile structure but mounted on concrete sump.Siphon breaker not in concrete riser but on steel pipe.Pipe is not 8 ft. below the crown but 4 ft below the crown.Looks original pipe was replaced with new crossing. Needs more information from LMA or DWR Inspector. (P. Amatya - DWR) FIELD_STRUCT_DESC: 12-inch (not 14-inch as referenced in Permit No. 3492-A) asphalt coated steel pipe through the levee, 4 feet below the crown. Pump mounted on a concrete sump in a drain ditch approximately 200 feet off the landside (LS) toe. Siphon breaker on the apex of the pipe through the waterside (WS) slope. (Permit No. 3492, 1962 - RD2075) (Additional Related Permit(s): 3492-A, 1969 - RD2075). [Additional Reference(s): DWR Levee Log, 2005. USACE San Joaquin O&M Manual 003, Dec 1968 (HLM 5.52)]. Note O&M Manual references a 16-inch pipe with a depth of 8 feet at this location, which was replaced under Permit No. 3492 with a 6-inch pipe, which was replaced with a 14-inch pipe under Permit No. 3492-A. FS Date: 6/21/2016

LS view: pipe, pump and concrete sump in the drain ditch.

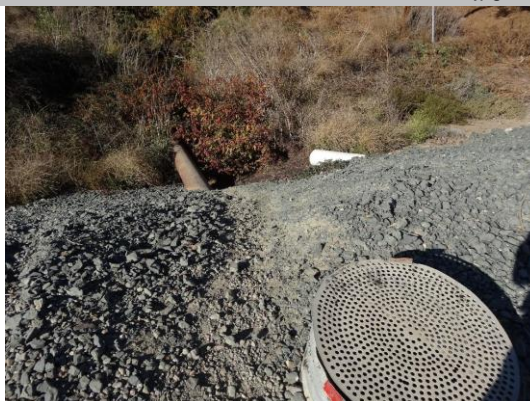
Photo 1 of 2 : UCIP_FA_2016_50213_45613.jpg

FS_ID:50213
DS_ID:24742
EP_NO: 4051
Repair Type: Non-Urgent
Crossing Status: Found
UCIP Comments: 06/21/2016: Erosion repaired with rock revetment and crown regraded. Pipe is crushed and deformed on LS. PVC pipe has been removed. Crossing has been downgraded from Urgent to Non-Urgent. 11/13/2013:- exposed deformed pipe on landside slope. Soil erosion also occurred around the deformed pipe. Walkway at pump on LS toe in poor structural condition.- a temporary 12-inch PVC pipe also found on both sides of the levee.
FIELD_STRUCT_DESC: 12-inch drainage pipe through the levee, 5.5 feet below the crown. Pump mounted over concrete sump at the landside (LS) toe. Siphon breaker in corrugated metal riser unit on the waterside (WS) shoulder. 12-inch polyvinyl chloride (PVC) pipe 1 foot below the crown, installed through the levee for emergency use during 1986 floods (not found in 2016). (Permit No. 4051, 1962 - RD2075). [Additional Reference(s): DWR Levee Log, 2005. USACE San Joaquin River O&M Manual 003, December 1968 (HLM 6.79)].

WS view: CMP riser (bottom) on levee shoulder. Steel pipe (top) and temporary pvc pipe on levee slope.

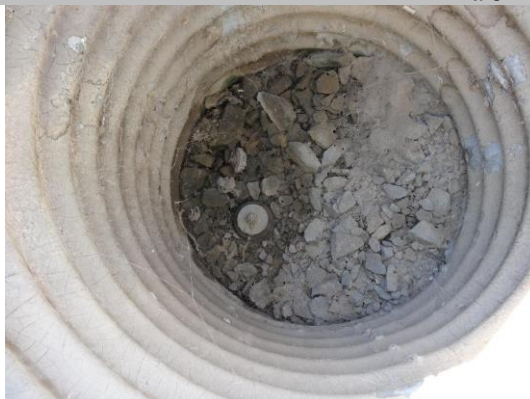
Photo 2 of 2 : UCIP_FA_2016_50213_45612.jpg

WS view: siphon breaker in CMP riser on levee shoulder.
